## Safety Bulletin

### Divator DP1 Surface Supply

99 450A01

#### ANNOUNCEMENT

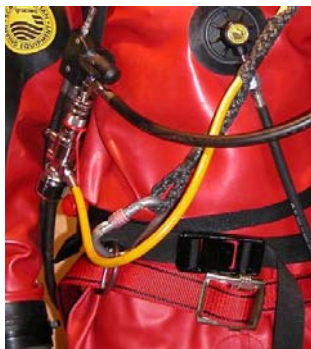
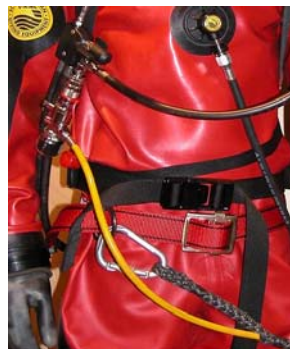
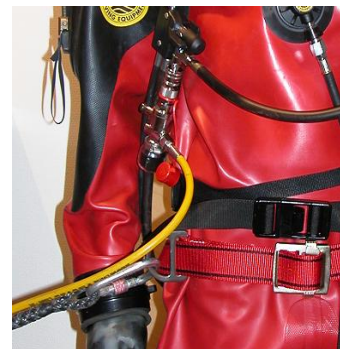
Examples of relieving loop attachment to the life belt

*“Diver and attendant are responsible to anchor the umbilical in such a way that the end couplings and nipples do not get bent, or get loaded independently of load directions in the umbilical. This is very important and must be carefully checked.”*
